Collapse Report Stirs Debate on Epoxies

Answers to Central Artery/Tunnel epoxy controversy slowly unfold as firms speak out

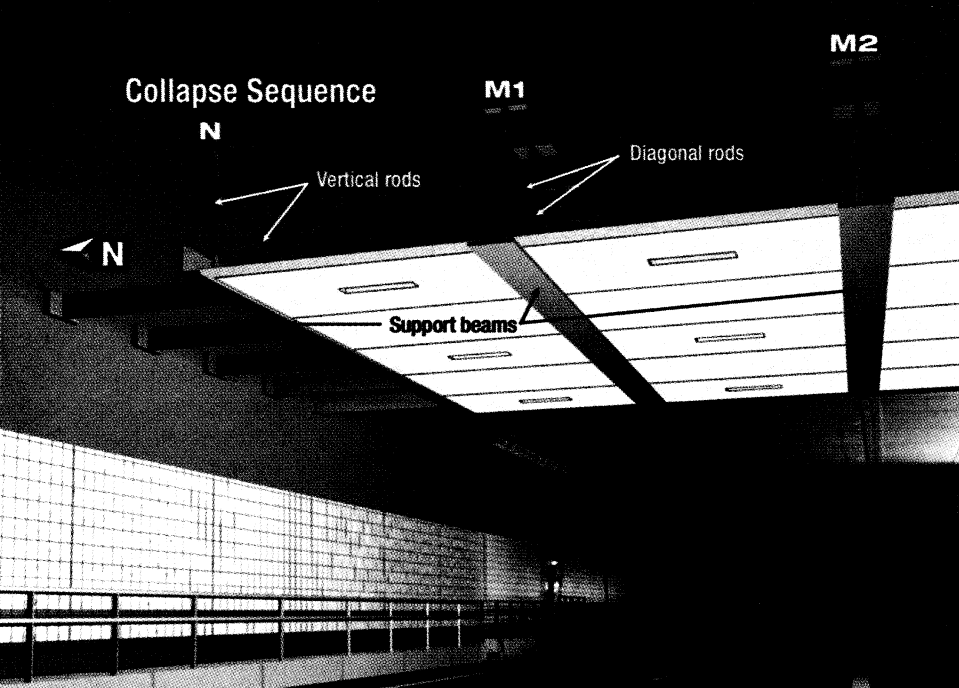
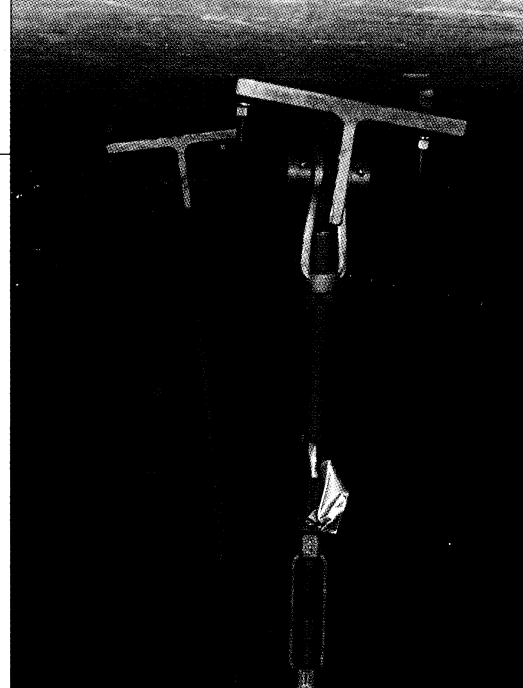
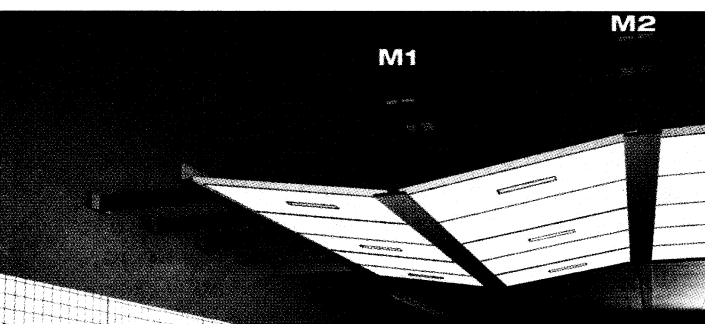
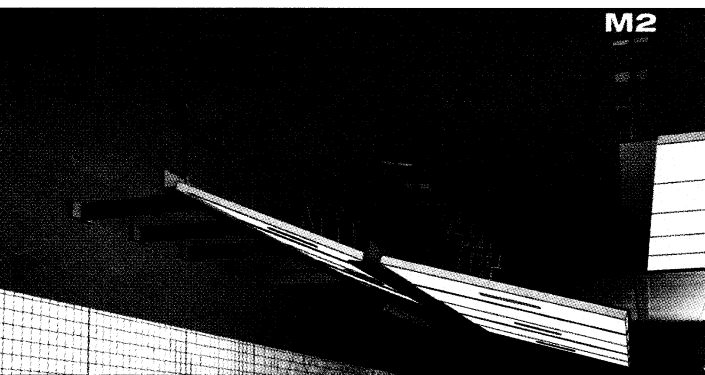
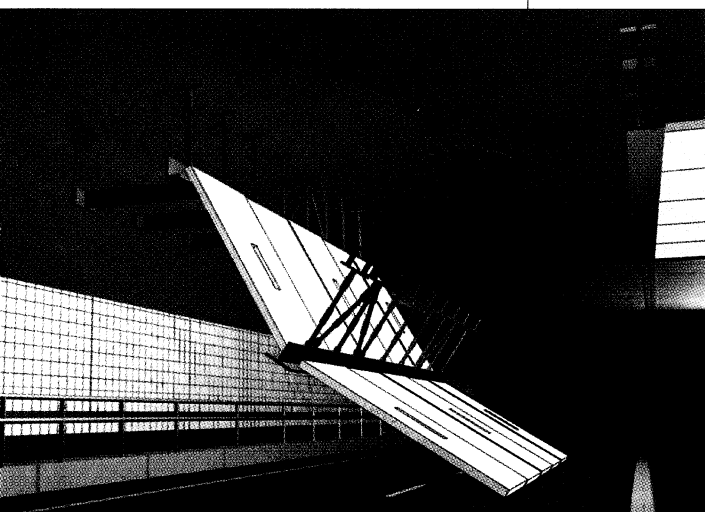
▲ **Weak Point.** Failure of the central M1 support structure due to anchor creep released 10 precast panels and hardware totaling 52,000 lb.

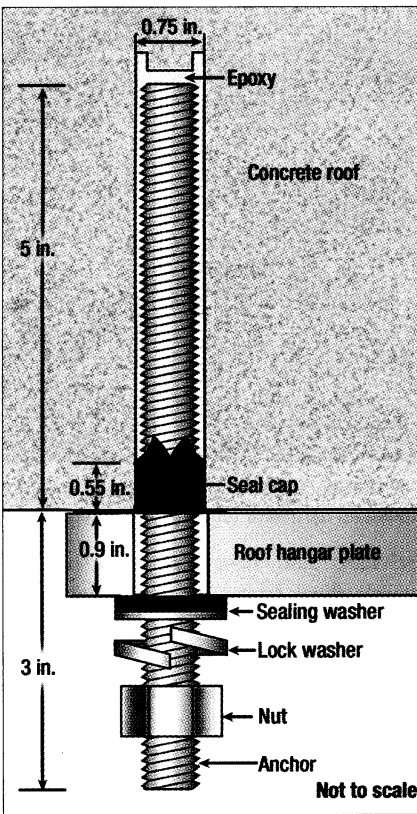
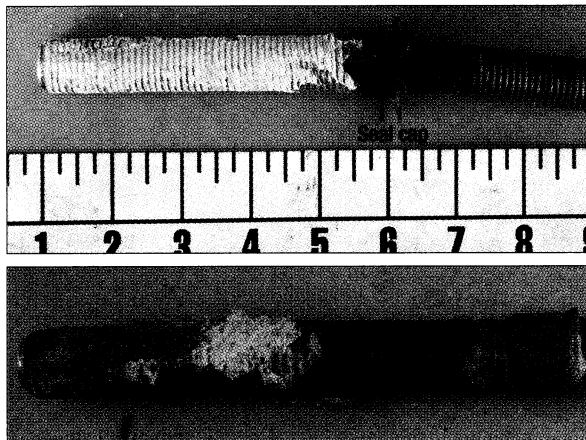
▲ **Tough Job.** Eight-inch threaded bolts were pull-tested but investigation showed that 19 of 20 failure-area anchors had voids. Top photo depicts good installation; bottom shows voids in red.

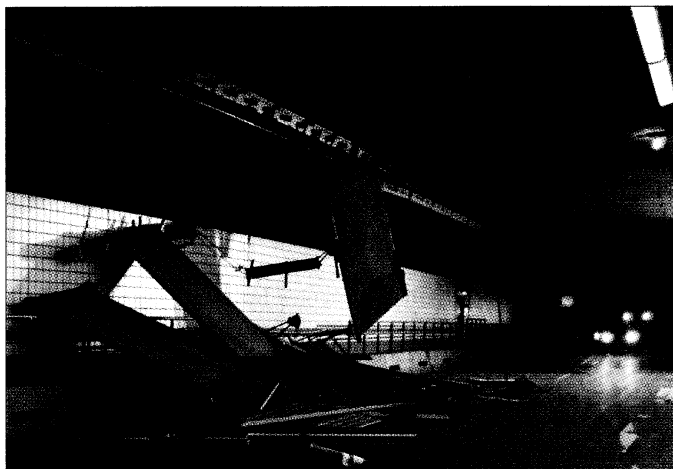
▲ **Fatal Landing.** A 38-year-old Boston woman died in ceiling collapse.
